## Scanning electron microscopic evaluation of root surface morphology after root planing with curettes and ultrasonic perio mini-tip: An in vitro study

**Keywords:** Root planing, Curettes, Ultrasonic perio mini-tip, Scanning electron microscope.

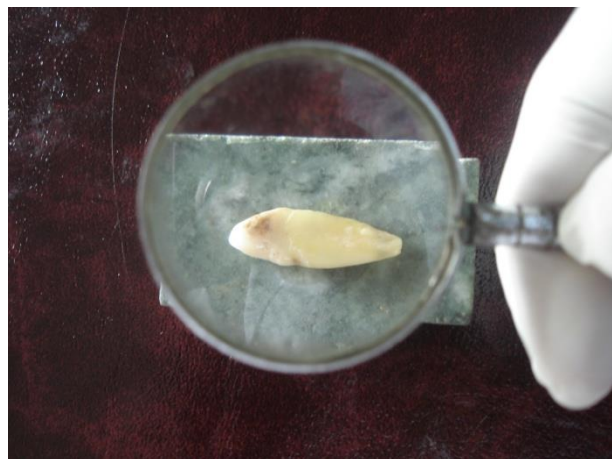
**Fig. 1:** Viewing the CEJ under magnifying glass

Each caries-free surface of a tooth was examined visually and also with a magnifying glass to determine the anatomical location of cemento-enamel junction (CEJ) (Fig. 1). A tentative area on the root surface extending up to a length of 5mm apically from the CEJ was properly

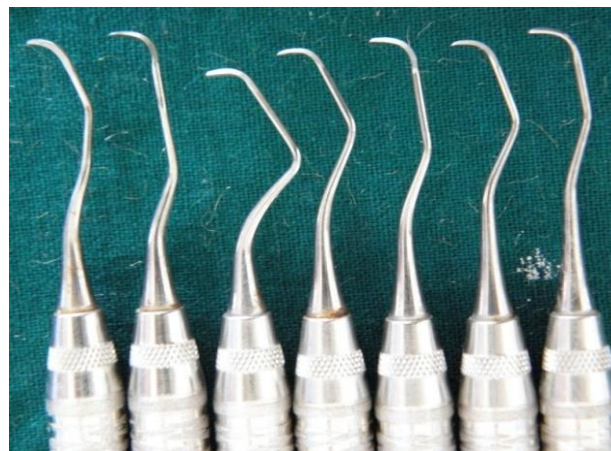
**Fig. 2:** A set of Gracey curettes

1. Gracey's area specific curettes (SG 1/2 – SG 13/14, Hu-Friedy) (Fig. 2).
2. Ultrasonic piezoelectric perio mini-tip (H3, Satelec Acteon)(Fig. 3a & 3b).

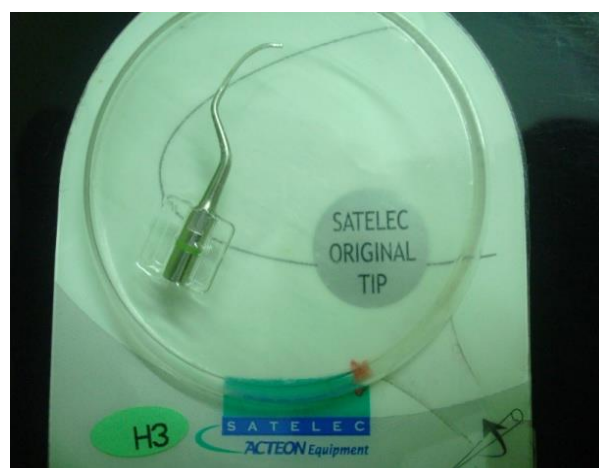
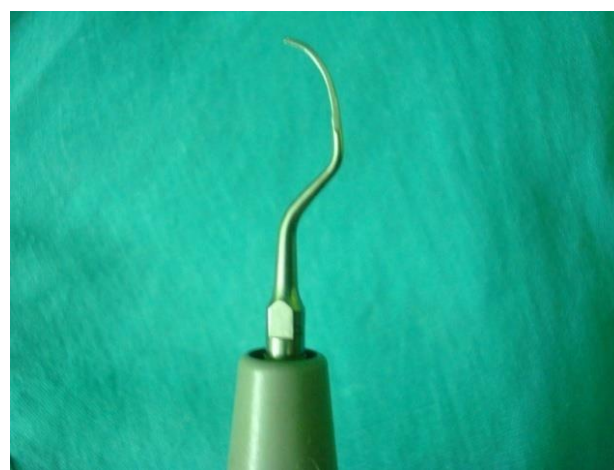
**Fig. 3a:** Ultrasonic perio mini-tip in sealed pack

**Fig. 3b:** Enlarged view of the perio mini-tip

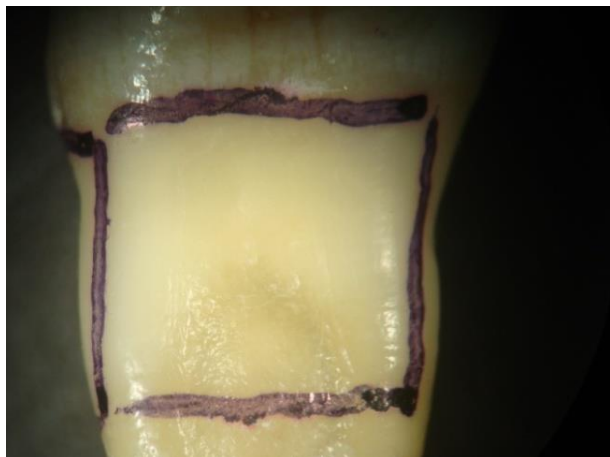
**Fig. 4:** Demarcated area of instrumentation

demarcated with a marker pen. All the proceedings of root planing were conducted within this demarcated area on the root surface.

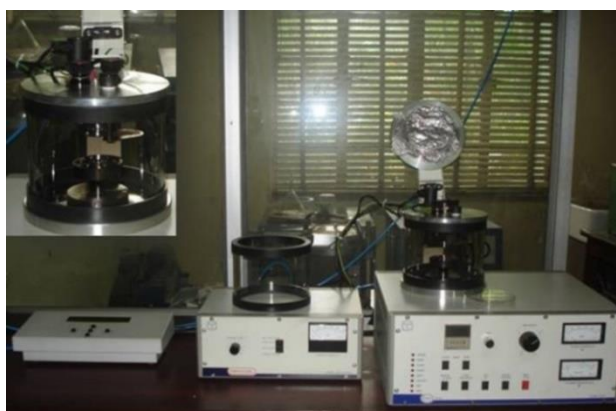
**Fig. 5:** Gold-sputtering machine (IB-2 ION COATER). Inset picture shows enlarged view of the sputtering chamber

Selected teeth from the experimental groups were fixed on the stub of the IB-2 Ion Coater gold-sputtering machine (Fig. 5) and the cover was put on to make the area air-tight. With the help of an air suction machine, air was taken out from the sputtering bottle to make the chamber vacuumised and sputtering was done with pure gold. The gold sputtered tooth surface (Fig. 6) was then transferred to the SEM machine (Hitachi S-530, Japan) (Fig. 7) and the area of interest on the root surface was examined at fixed magnifications of 50x and 100x. Suitable areas of observation were photographed and presented in Results and Observations.

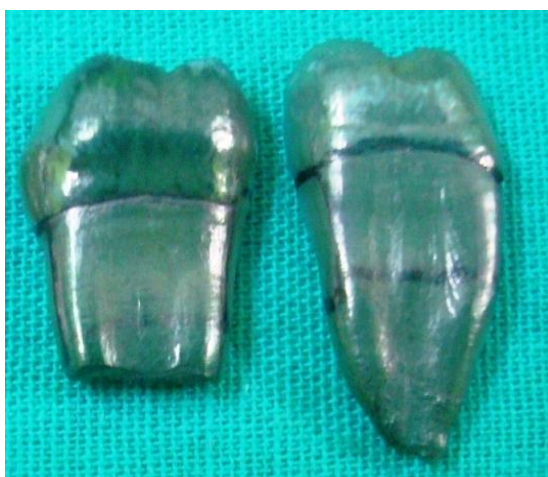
**Fig. 6:** Tooth samples after gold coating

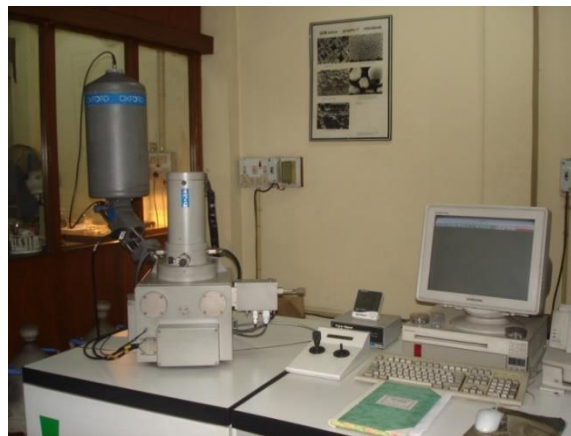
**Fig. 7:** Scanning electron microscope (HITACHI S-530)

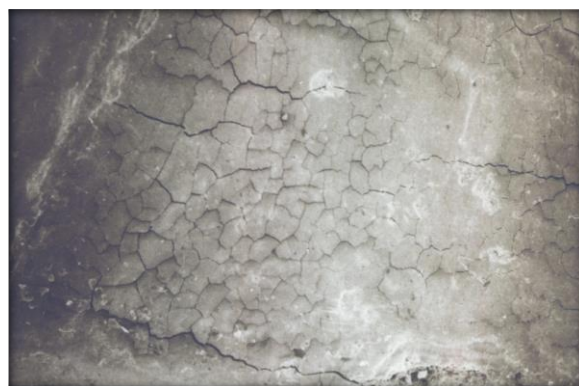
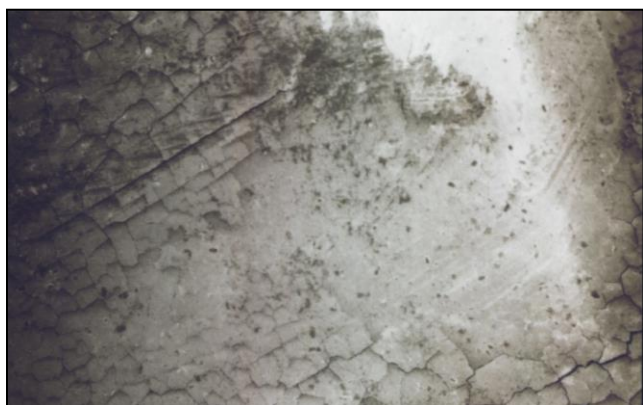
**Fig. 8:** SEM view of test side instrumented for 50 strokes with curette. 50x

**Fig. 11:** SEM view of test side instrumented for 50 strokes with curette. 100x

Fig. 8 and Fig. 11 represent SEM photomicrographs of the root surface of a representative sample from subgroup- $AC_1$  under experimental group-A (test side instrumented for 50 strokes with curette), viewed under 50x and 100x magnifications respectively. Under 50x magnification, the test side shows some rough and definitely corrugated patches where cementum is removed and instrumentation marks or scratches can be seen on dentin, although most of the cementum is still present on the root surface. Cemental cracks are evident on the residual cementum, which occurs as a result of dehydration process that the cementum undergoes due to alcohol treatment before it is gold-sputtered prior to viewing under SEM. In terms of cleanliness, plaque and smear layer are not evident under 50x magnification, except for a few isolated and scattered particles of debris. Residual embedded calculus particles in cementum cannot be appreciated under 50x magnification but under 100x magnification, some isolated dark particles can be seen scattered on the root surface along with one or two dark patches, which are suggestive of residual, calculus particles within the unremoved cementum. In addition, under 100x magnification, instrumentation scratches can be more clearly appreciated in the roughened or corrugated areas where cementum is completely removed.

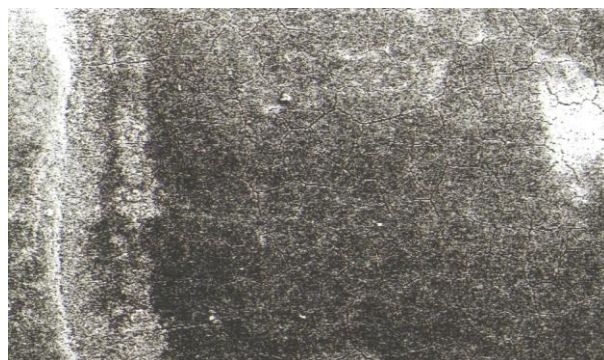
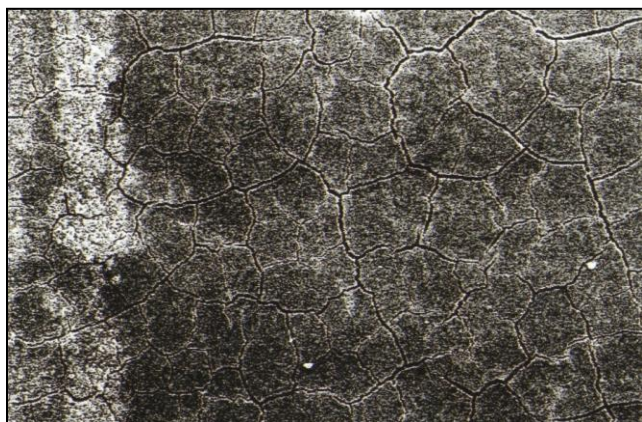
**Fig. 9:** SEM view of test side instrumented for 100 strokes with curette. 50x

**Fig. 12:** SEM view of test side instrumented for 100 strokes with curette. 100x

Fig. 9 and Fig. 12 show SEM photomicrographs of root surface of a representative sample from subgroup- $AC_2$  under experimental group-A (test side instrumented for 100 strokes with curette), viewed under 50x and 100x magnifications respectively. Under both 50x as well as 100x magnifications, the test side exhibits a relatively uniform smooth surface. There is no undue loss of tooth substance. Most of the root surface cementum has been conserved. Cementum exhibits cracks all over its surface. There is no evidence of any instrumentation marks or scratches even under higher magnification of 100x. There are no rough or corrugated patches where cementum has been aggressively removed. There is no evidence of any patches of remaining calculus. There is no evidence of plaque or smear layer except for a few scattered particles of debris. Overall, the root surface presents a relatively clean and smooth surface topography.

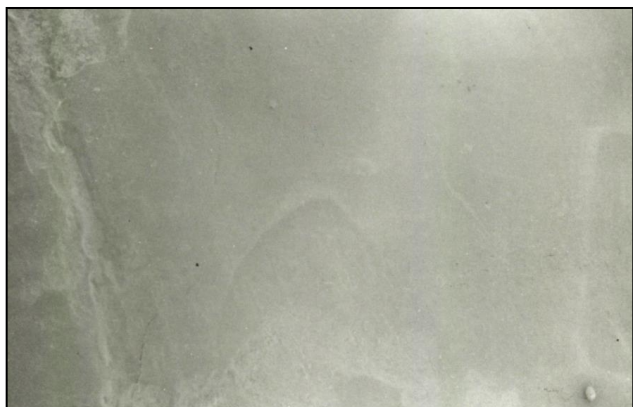
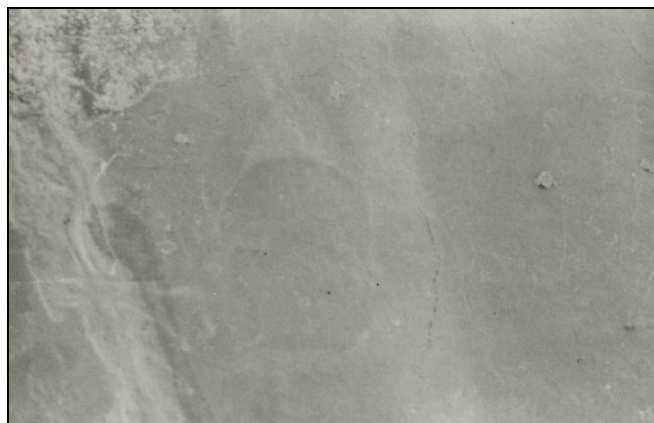
**Fig. 10:** SEM view of test side instrumented for 150 strokes with curette. 50x

**Fig. 13:** SEM view of test side instrumented for 150 strokes with curette. 100x

Fig. 10 and Fig. 13 show SEM photomicrographs of root surface of a representative tooth sample from subgroup- $AC_3$  under experimental group-A (test side instrumented for 150 strokes with curette), viewed under 50x and 100x magnifications respectively. Here, the root surface appears extremely smooth and very well polished. There are no visible cemental cracks. There are no rough patches or corrugated areas over the root surface, suggestive of the fact that all the necrotic cementum has been uniformly removed and root surface exhibits a very clean, smooth and uniform surface topography, probably with good exposure of dentin. There is no evidence of any patch or flecks of remaining calculus, no evidence of plaque, smear layer or debris.

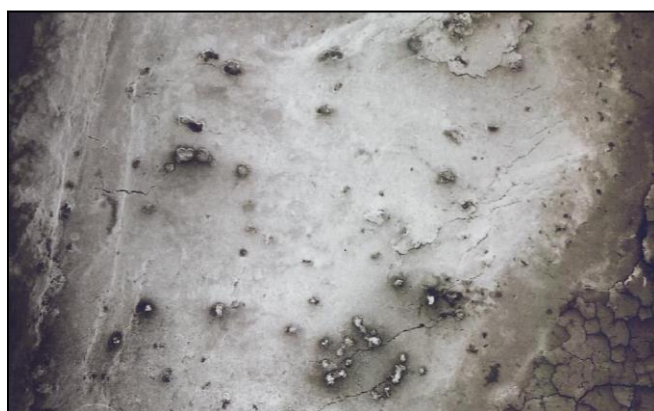
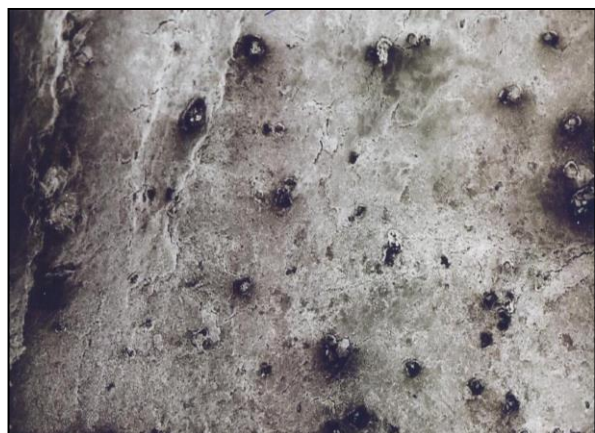
**Fig. 14:** SEM view of test side instrumented for 15 seconds with ultrasonic perio mini-tip. 50x magnification.

**Fig. 17:** SEM view of test side instrumented for 15 seconds with ultrasonic perio mini-tip. 100x magnification.

Fig. 14 and Fig. 17 show SEM photomicrographs of the root surface of a representative tooth sample from subgroup-

B<sub>U1</sub>, under the experimental group-B (test side instrumented for 15 seconds with ultrasonic perio mini-tip), viewed under 50x and 100x magnifications respectively. Here, the root surface presents definitely corrugated areas or rough patches confined to the cementum. This suggests that all the necrotic cementum is not uniformly removed, resulting in certain degree of root surface roughness. Cemental cracks are also evident, although lesser in number. Root surface also shows isolated particles scattered all over the cementum as slight projections, probably suggestive of debris or particles of smear layer. Minute particles of embedded residual calculus are also evident, scattered as isolated dark particles over the root surface cementum. However, scratches due to instrumentation are not seen.

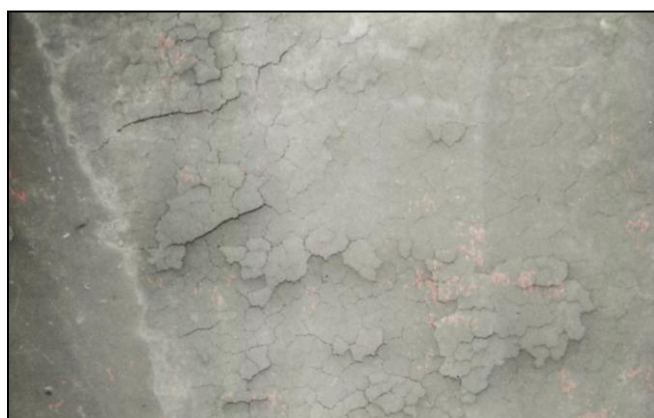
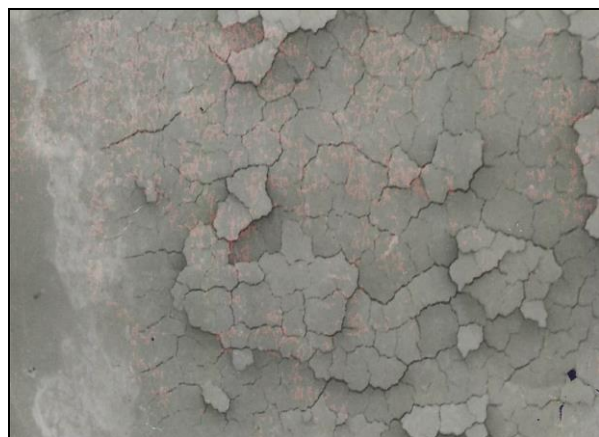
**Fig. 15:** SEM view of test side instrumented for 30 seconds with ultrasonic perio mini-tip. 50x magnification.

**Fig. 18:** SEM view of test side instrumented for 30 seconds with ultrasonic perio mini-tip. 100x magnification.

Fig. 15 and Fig. 18 show SEM photomicrographs of the root surface of a representative tooth sample from experimental subgroup-B<sub>U2</sub>, under Group-B (test side instrumented for 30 seconds with ultrasonic perio mini-tip), viewed under 50x and 100x magnifications respectively. Here, the root surface exhibits slightly corrugated local areas confined to the cementum. Cemental cracks are evident in abundance. Cemental surface does not appear to be uniformly smooth. Localised areas of undulations are evident within the cementum just below the CEJ, suggestive of the fact that probably all the affected cementum has not been removed. Therefore, it indicates insufficient removal of affected cementum. However, scratches due to ultrasonic instrumentation are not seen. Cemental surface is devoid of any debris, smear layer or isolated flecks or patches of remaining calculus.

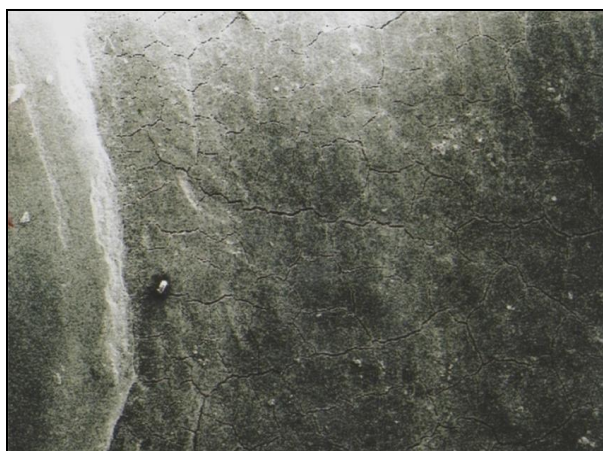
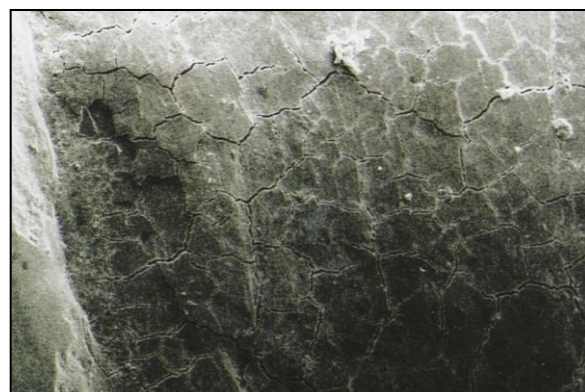
**Fig. 16:** SEM view of test side instrumented for 45 seconds with ultrasonic perio mini-tip. 50x magnification.

**Fig. 19:** SEM view of test side instrumented for 45 seconds with ultrasonic perio mini-tip. 100x magnification

Fig. 16 and Fig. 19 show SEM photomicrographs of root surface of a representative sample tooth from experimental subgroup-B<sub>U3</sub>, under Group-B (test side instrumented for 45 seconds with ultrasonic perio mini-tip), viewed under 50x and 100x magnifications respectively. Here, the cemental surface shows relatively smooth and uniform surface topography. Cemental cracks are evident in abundance. There is no substantial loss of tooth structure. Root surface is devoid of calculus, plaque or smear layer, except for a few isolated particles of debris.
